Home Inspection Report

123 Main Street , Kitty Hawk, NC 27949

Monday, January 1, 2018

Sandbar Home Inspection

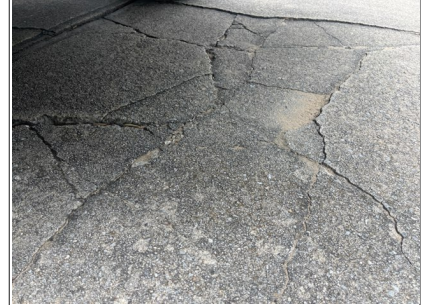
Driveway had cracking that indicated settlement at multiple locations. No areas presented a trip hazard at the time of inspection. Recommend a licensed concrete installation professional should evaluate condition of driveway and make any necessary corrective actions.

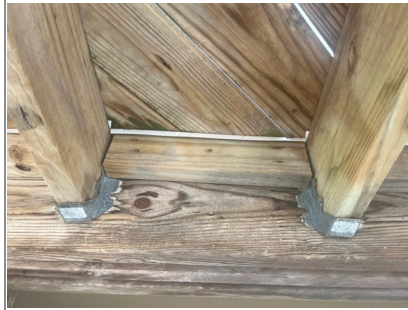
No ledger board installed at S deck system only. A ledger board is essential in the connection between deck/home. Current installation has the floor joists and ledger strip connected to the band joist only. A licensed deck repair professional should evaluate for installation of a ledger board at this location.

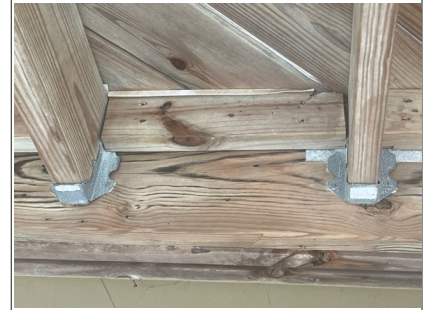
Improper fasteners used for the piling/rim joist connection points throughout the W end of deck system, with the WSW corner rim joist no longer fully bearing on the notch. Generally accepted safe building practices recommend all connections of this type be done so with bolts or lag screws as the fastener for enhanced stability. Current orientation has nails used as the only fasteners, which can lead to joists moving from the notched piling. A licensed deck professional should evaluate for any necessary corrective actions to ensure rim joist connections remain secure.

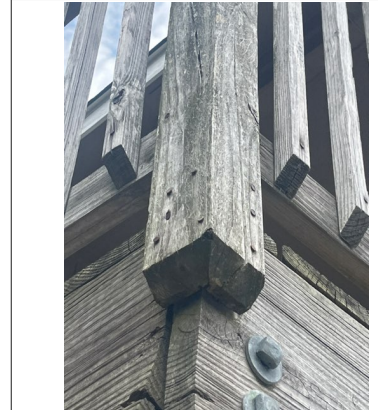
Posts at railings throughout deck system are not properly secured at the joist connection point. Generally accepted safe building practices recommend lag bolts, thru bolts, or carriage bolts be used to secure the posts for railings. It in its current orientation, nails only are being used. Recommend a licensed repair professional evaluate for any necessary corrective actions to ensure safe continued usage of the railing system throughout deck.

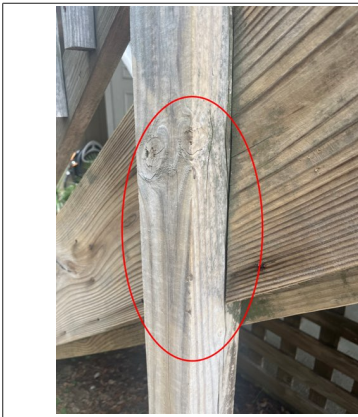
Improper fasteners used for W deck stair support posts. Generally accepted safe building practices recommend these connection be made with bolts of lag screws at 4"x4" posts that sit flush with the stringer, if not carried through to the railing. Current installation has nails only installed. For enhanced stability at these areas, a licensed deck professional should evaluate supports and make any necessary corrective actions.

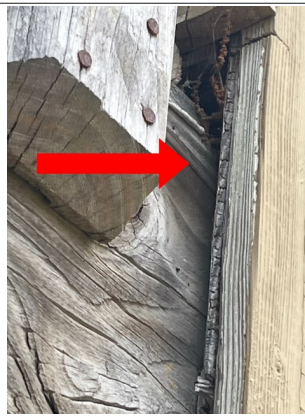
No visible flashing present at the connection point between the NE corner of S deck system and home. To ensure moisture cannot penetrate at this location, a licensed deck repair professional should evaluate area and determine if additional corrective actions are necessary

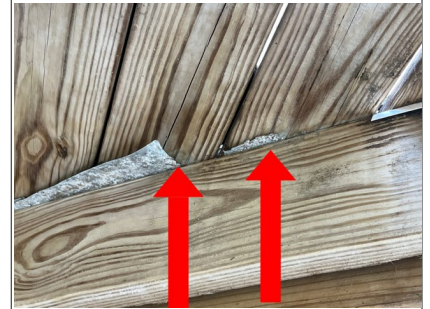
Cap flashing is damaged at multiple locations at areas installed above ledger board at the W deck only. This flashing ensures moisture cannot sit against the the home. To restore originally intended functionality, a licensed deck professional should evaluate cap flashing throughout this deck and make any necessary corrective actions

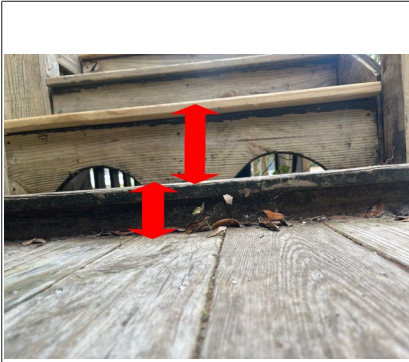
Risers at the lower end of W deck stairs are not uniform. Fall hazard. Generally accepted safe building practices recommend all riser heights be uniform, to ensure occupants can safely use stairs. Current installation has a 3" disparity between the lowest riser and the next riser above. A licensed deck professional should evaluate riser heights for reconfiguration at this location

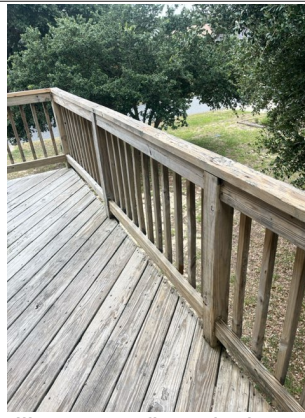
W railing at top floor deck was loose. Fall hazard. A licensed deck repair professional should evaluate and make any necessary corrective actions ensure safe usage of the railing at this location

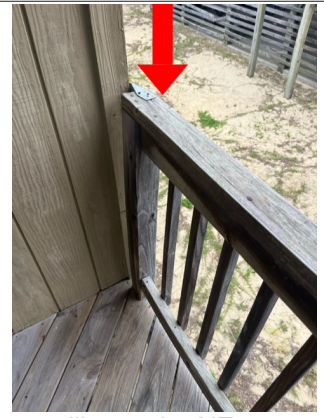
Loose railing at the NE corner of top floor S deck. Fall hazard. A licensed deck repair professional should evaluate and make any necessary corrective actions to ensure safe usage of the railing at this location

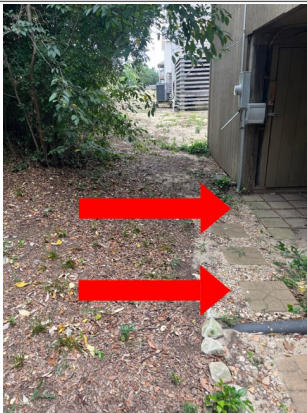
Negative grade at N and E exterior, with the yard pitched towards the home. A sump is currently installed at the N exterior. No signs of damage or moisture penetration at interior N or E exterior walls. To ensure moisture cannot penetrate at these locations, a licensed landscape professional should evaluate grading around home and determine if additional corrective actions are recommended

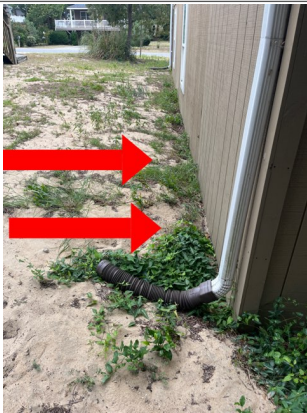
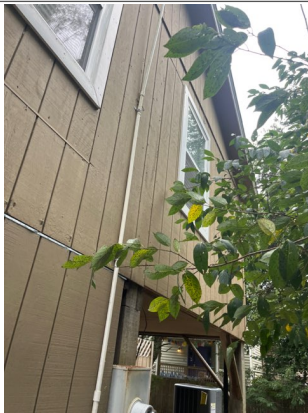
While not currently in contact, tree limbs at N exterior are in close proximity to the exterior siding. When in contact, tree limbs trap moisture and can cause deterioration. A licensed landscape professional should prune back tree limbs at this location

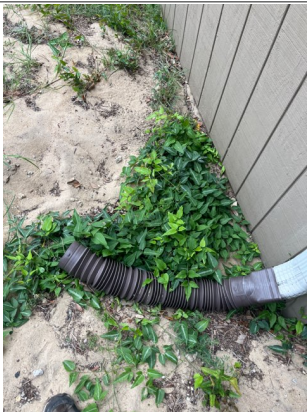
Due to the negative grade, NE corner Downspout terminates at the base of the home. While an extender is currently installed, it likely terminates runoff that pools against the home. A licensed gutter technician should evaluate termination point to be extended.

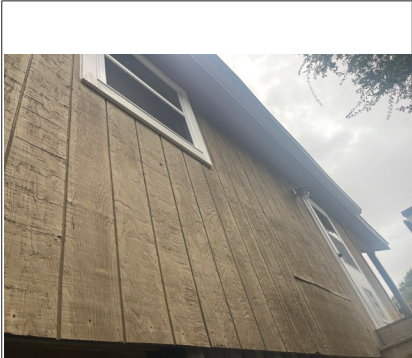
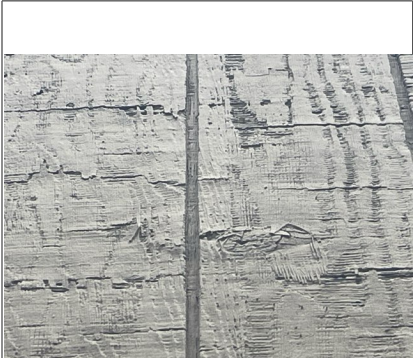
Deterioration present at some areas of siding system, with a higher concentration of these areas at the W and N exteriors. While some sections of siding have been previously replaced, sections that have not appear to be nearing an end to their typical useful lifespans. To ensure moisture cannot penetrate at these areas of siding, a licensed siding professional should evaluate condition of all siding and repair/replace as needed

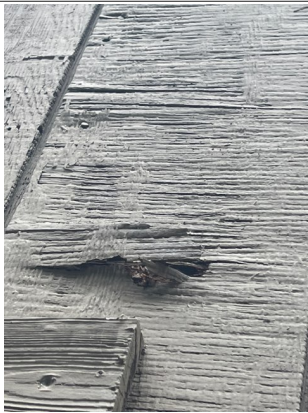
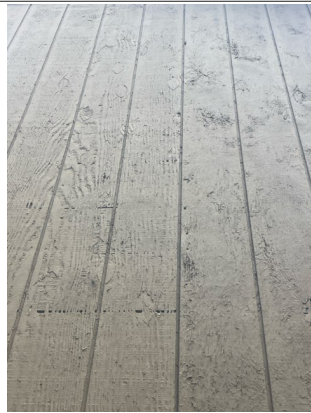
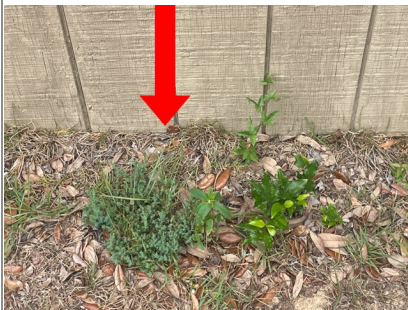
Siding at E side exterior is in contact with soil at multiple locations. This can trap moisture against siding and reduce its useful lifespan. It is recommend 4-6" of clearence between initial row of siding and the ground. A licensed landscape professional should evaluate for any necessary corrective actions to extend useful lifespan of the siding at these locations.

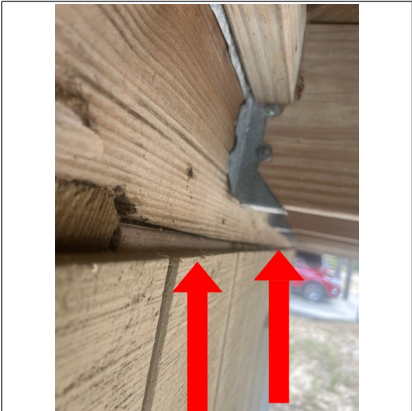
No flashing installed above the upper edge ground floor SSE exterior siding. To ensure moisture cannot penetrate at this location, a licensed general contractor should evalaute and make any necessary corrective actions

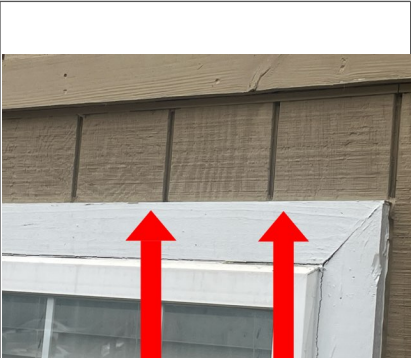
"Z" Flashing not installed at the upper edges of trim above horizontal trim, windows and doors at the exterior. To ensure moisture cannot penetrate and these upper edges, a licensed repair professional should evaluate condition at these edges and consider adding this flashing where neccesary as an upgrade

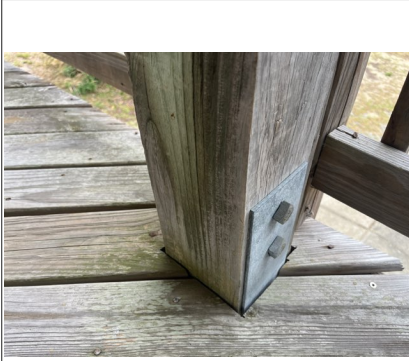
Improper fasteners used for the piling and girder connection points supporting top floor S porch roof system. Generally accepted safe building practices recommend all connections of this type be done so with bolts or lag screws as the fastener for enhanced stability. Current orientation has nails used as the only fasteners at some of these locations, which can lead to joists moving from the notched piling. A licensed repair professional should evaluate for any necessary corrective actions to ensure rim joist/girder connections remain secure.

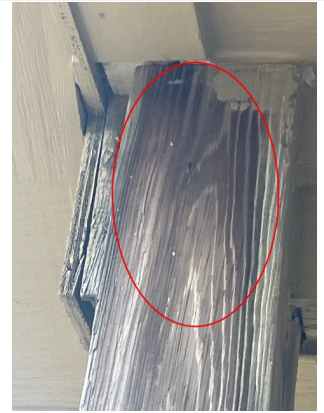
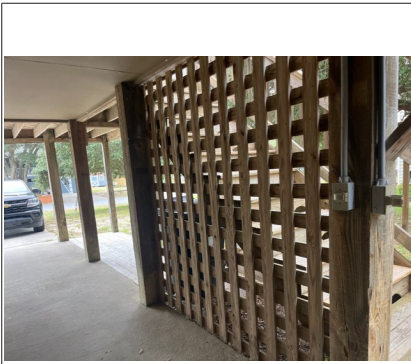
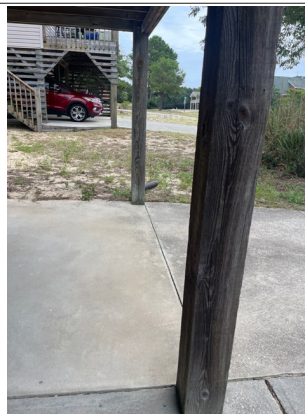
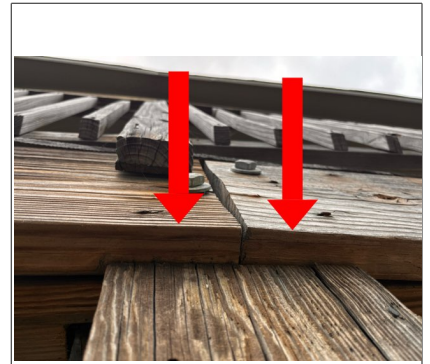
Some rim joists under the S end of top floor porch are bowed, and are no longer fully bearing onto notched pilings. To ensure these joists are able to continue to function as designed, a licensed general contractor should evaluate their condition and make any necessary corrective actions

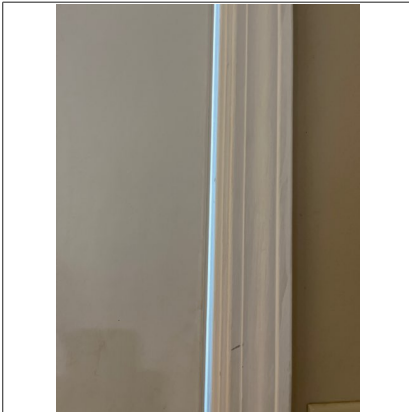
Open gap between top floor W central exterior door and frame, allowing exterior air to penetrate. For enhanced HVAC efficiency and to restore seal around door, a licensed repair professional should evaluate door/weatherstripping and make any necessary corrective actions

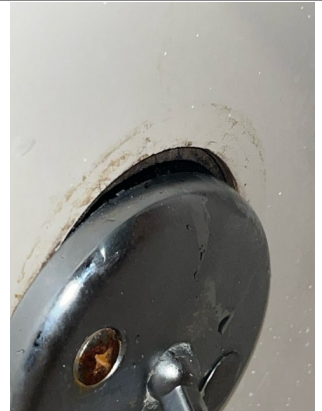
Open gap at the upper edge of plate over trip lever at tub. To ensure moisture cannot penetrate at this location during typical shower/tub usage, a licensed repair professional should evaluate and make any necessary corrective actions

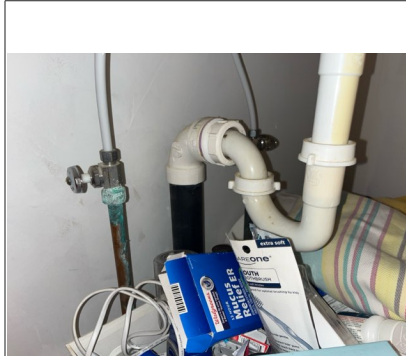
"S" trap being used under sink. While common at the time of initial construction, modern day plumbing techniques recommend the replacement of S traps. This is due to the lack of seal at the trap, allowing sewer gas to penetrate through the sink. A licensed plumber should evaluate for reconfiguration.

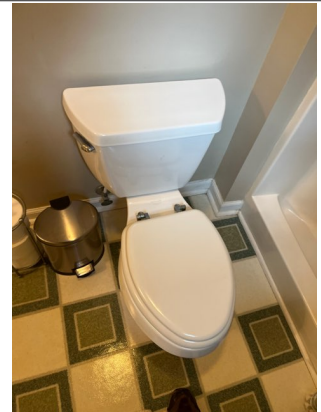
Toilet bowl was loose at the time of inspection. No apparent damage or moisture staining around the toilet or at the ceiling below this location. A licensed plumber should evaluate for any necessary corrective actions.

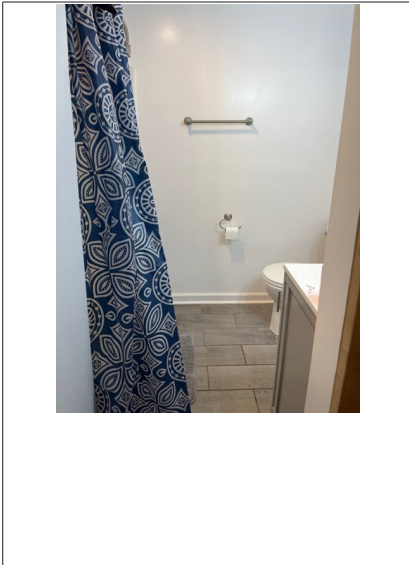
Drainage at sink was marginal during testing. To restore originally intended functionality, a licensed plumber should evaluate for repair.

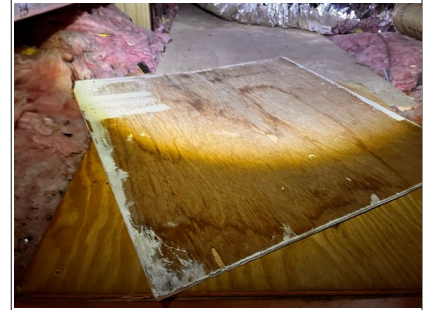
Exhaust ducting from top floor NW bathrooms fan terminates into the attic. These ducts should be routed to terminate at the exterior. Current installation has all the humidity and moisture from the bathroom, exhausting into the attic. To ensure no moisture problems occur, a licensed repair professional should reconfigure termination point of the exhaust duct to the exterior.

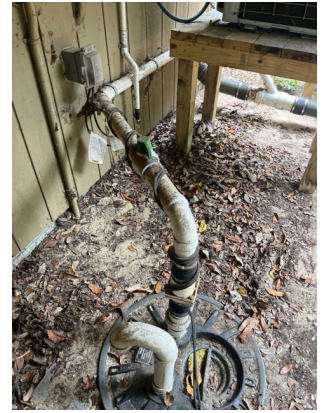
Sump discharge pipe is improperly installed. Current installation has the sump terminating into the drain, waste and vent pipes for the septic system. Generally accepted best plumbing practices recommend that the discharge point be separate from the dwv system. When connected, as is currently, the sump can overload the dwv/septic system and cause an overload. A licensed plumber should evaluate current design of sump system and make any necessary corrective actions

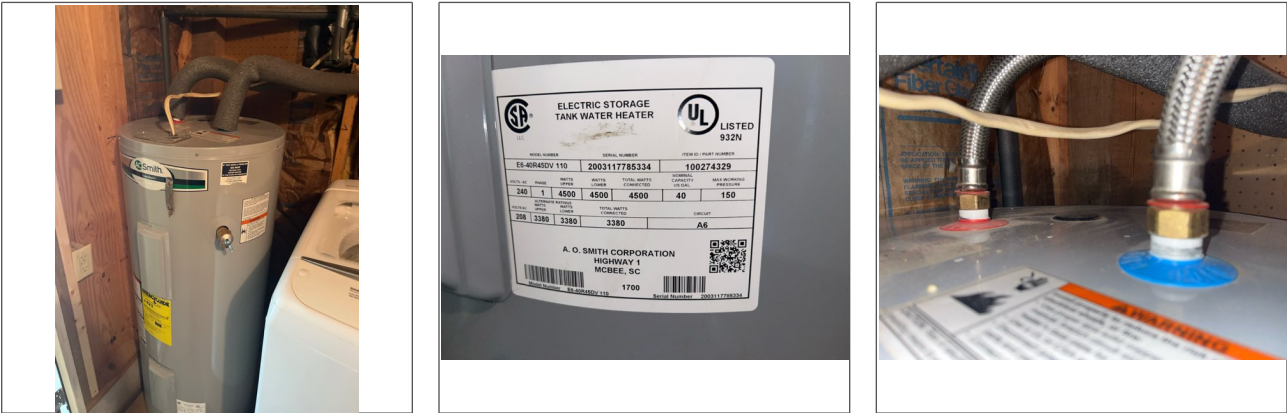
Expansion Tank not installed at the topside of unit. Generally accepted safe plumbing practices recommend a thermal expansion tank be installed between tank and cold water shutoff. A licensed plumber should evaluate for installation of a thermal expansion tank at this location,

Temperature pressure relief valve is not installed at water heater. Safety hazard. Tprv is typically installed to relieve pressure in the tank if a malfunction occurs. This can save the tank from combustion in an emergency situation. Recommend a licensed plumber evaluate for installation of a temperature pressure relief valve.

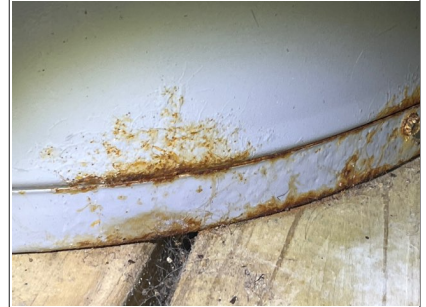
Rust observed at the base of tank at multiple locations. No damage apparent or moisture detected via moisture meter at any of these areas at the time of inspection. Recommend a licensed plumber should evaluate tank at this location and make any necessary corrective actions to extend useful lifespan of the unit.

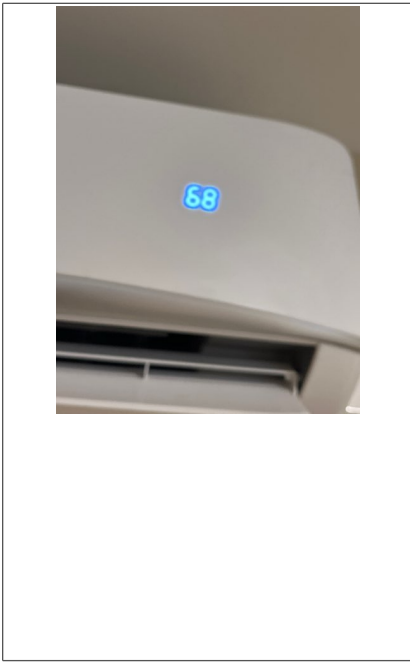
Filters at the unit was dirty and clogged. When proper airflow is not achieved, it can negatively affect functionality and effectiveness of the system during operation. Recommend cleaning filters throughout unit for enhanced usage.

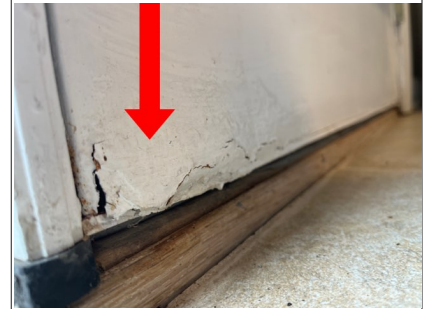
Damage at the base of more W door at S wall. While still functional, a licensed repair professional should evaluate condition of the door at this location and repair/replace as needed
