Home Inspection Report

123 Main Street , Kitty Hawk, NC 27949

Monday, January 1, 2018

Sandbar Home Inspection

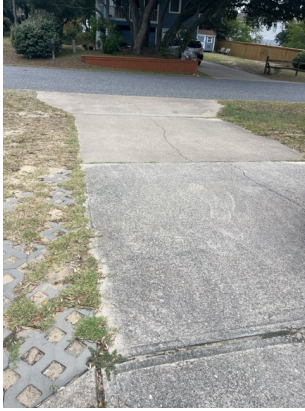
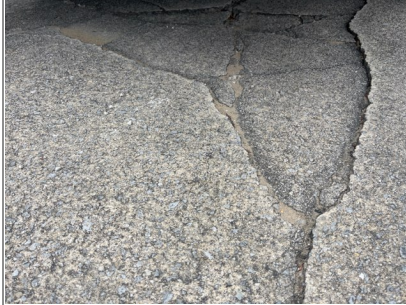
Condition ☒ **Marginal** ☒ Settling Cracks

Driveway had cracking that indicated settlement at multiple locations. No areas presented a trip hazard at the time of inspection. Recommend a licensed concrete installation professional should evaluate condition of driveway and make any necessary corrective actions.

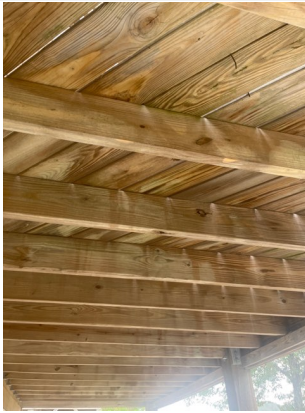
Finish ☒ Treated ☒ **Safety Hazard** ☒ Improper attachment to house ☒ Railing loose

No ledger board installed at S deck system only. A ledger board is essential in the connection between deck/home. Current installation has the floor joists and ledger strip connected to the band joist only. A licensed deck repair professional should evaluate for installation of a ledger board at this location.

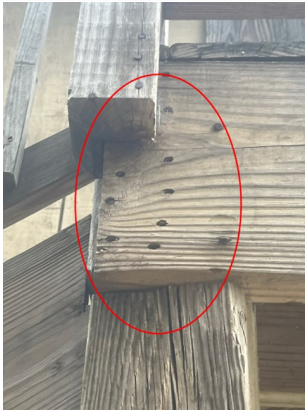
Improper fasteners used for the piling/rim joist connection points throughout the W end of deck system, with the WSW corner rim joist no longer fully bearing on the notch. Generally accepted safe building practices recommend all connections of this type be done so with bolts or lag screws as the fastener for enhanced stability. Current orientation has nails used as the only fasteners, which can lead to joists moving from the notched piling. A licensed deck professional should evaluate for any necessary corrective actions to ensure rim joist connections remain secure.

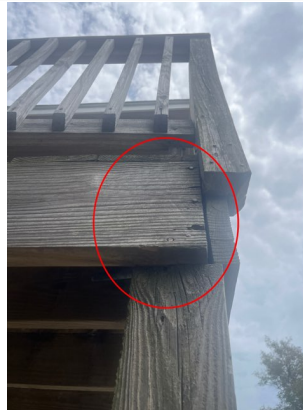
Posts at railings throughout deck system are not properly secured at the joist connection point. Generally accepted safe building practices recommend lag bolts, thru bolts, or carriage bolts be used to secure the posts for railings. It in its current orientation, nails only are being used. Recommend a licensed repair professional evaluate for any necessary corrective actions to ensure safe continued usage of the railing system throughout deck.

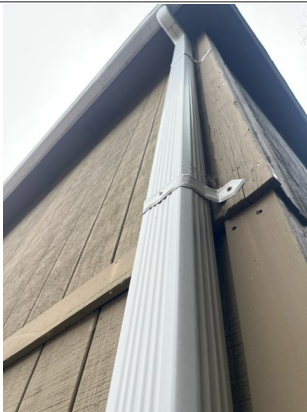
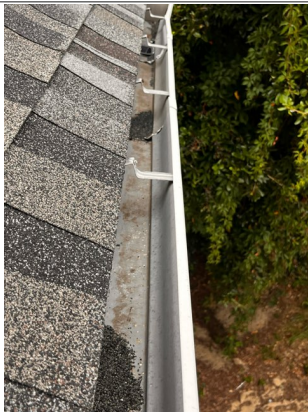
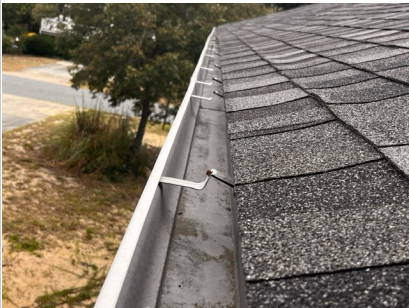
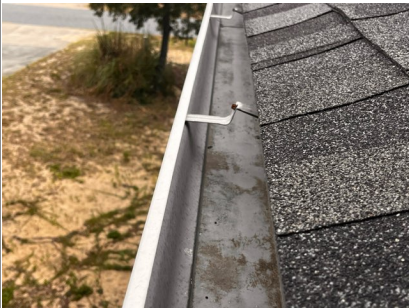
Due to the negative grade, NE corner Downspout terminates at the base of the home. While an extender is currently installed, it likely terminates runoff that pools against the home. A licensed gutter technician should evaluate termination point to be extended.

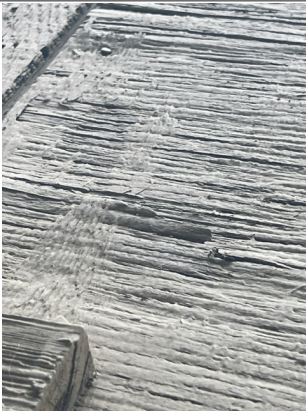
Deterioration present at some areas of siding system, with a higher concentration of these areas at the W and N exteriors. While some sections of siding have been previously replaced, sections that have not appear to be nearing an end to their typical useful lifespans. To ensure moisture cannot penetrate at these areas of siding, a licensed siding professional should evaluate condition of all siding and repair/replace as needed

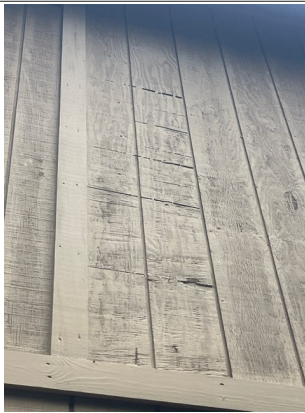
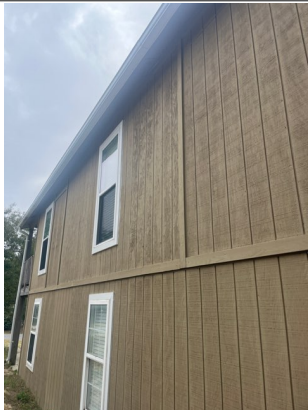
Siding at E side exterior is in contact with soil at multiple locations. This can trap moisture against siding and reduce its useful lifespan. It is recommend 4-6" of clearence between initial row of siding and the ground. A licensed landscape professional should evaluate for any necessary corrective actions to extend useful lifespan of the siding at these locations.

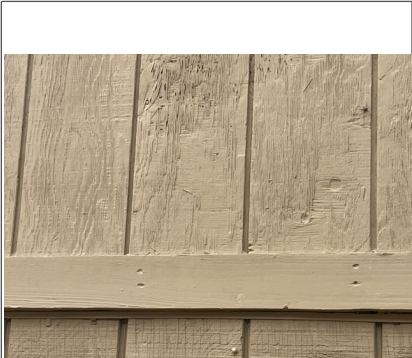
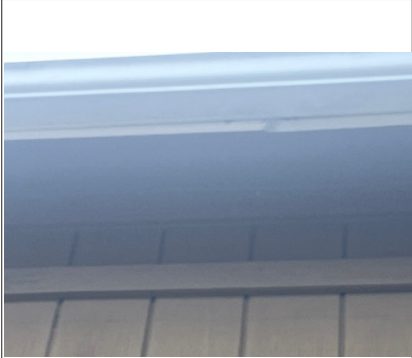
"Z" Flashing not installed at the upper edges of trim above horizontal trim, windows and doors at the exterior. To ensure moisture cannot penetrate and these upper edges, a licensed repair professional should evaluate condition at these edges and consider adding this flashing where neccesary as an upgrade

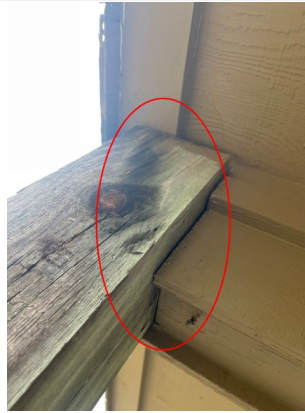
Improper fasteners used for the piling and girder connection points supporting top floor S porch roof system. Generally accepted safe building practices recommend all connections of this type be done so with bolts or lag screws as the fastener for enhanced stability. Current orientation has nails used as the only fasteners at some of these locations, which can lead to joists moving from the notched piling. A licensed repair professional should evaluate for any necessary corrective actions to ensure rim joist/girder connections remain secure.

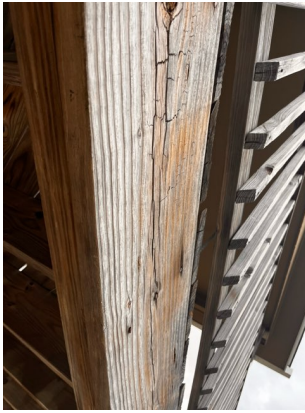
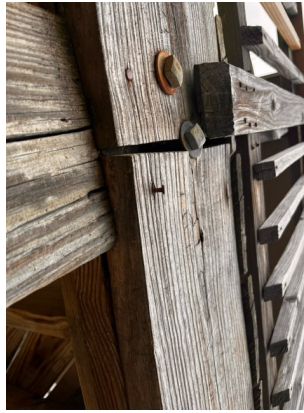
Some rim joists under the S end of top floor porch are bowed, and are no longer fully bearing onto notched pilings. To ensure these joists are able to continue to function as designed, a licensed general contractor should evaluate their condition and make any necessary corrective actions

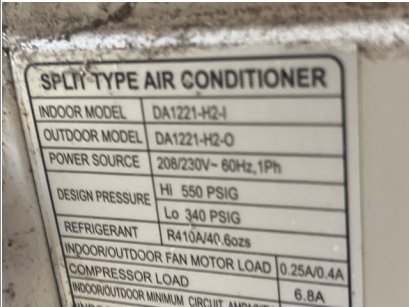
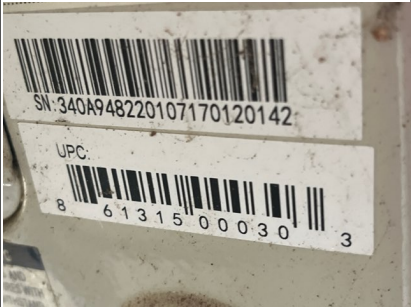
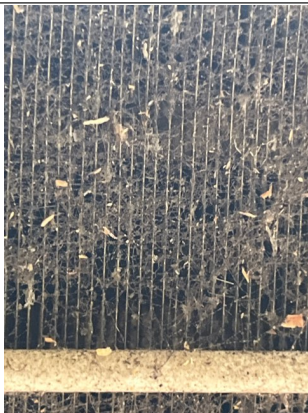
Buildup of organic debris at condenser fins throughout unit. This negatively affects efficiency and can reduce the useful lifespan of the unit. To ensure originally intended efficiency, an HVAC technician should evaluate for any necessary corrective actions.

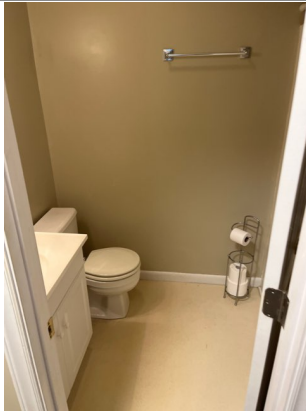
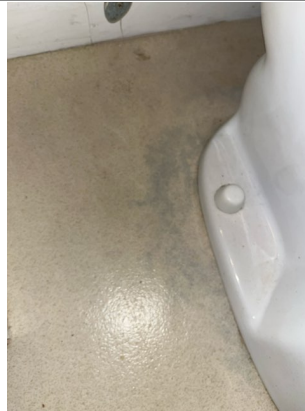
Staining at flooring around toilet. No moisture detected via moisture meter at these locations at the time of inspection. Recommend monitoring staining for any change in appearance or condition to ensure moisture cannot actively leak at this location

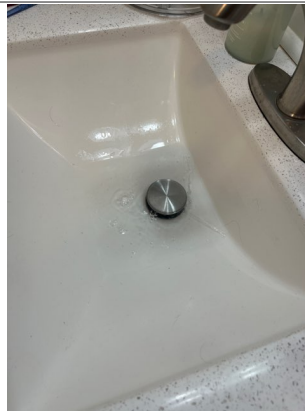
Drainage at sink was marginal during testing. To restore originally intended functionality, a licensed plumber should evaluate for repair.

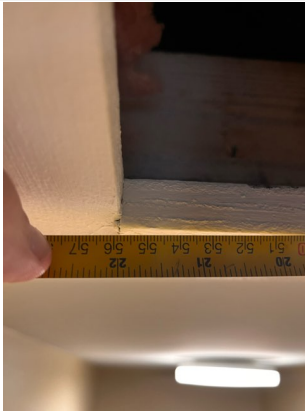
Scuttlehole access was not large enough. Generally accepted safe building practices recommend scuttlehole access no smaller than 20"x30" if there is a mechanical system in the attic. Current installation has the access at 22"x21". To ensure hvac professionals can remove existing air handler in attic when time to replace, a licensed repair professional should evaluate scuttlehole access and make any necessary corrective actions.

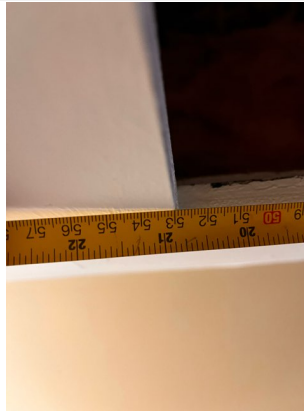
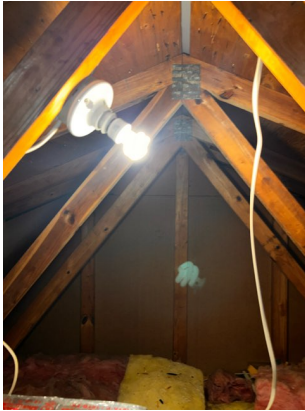
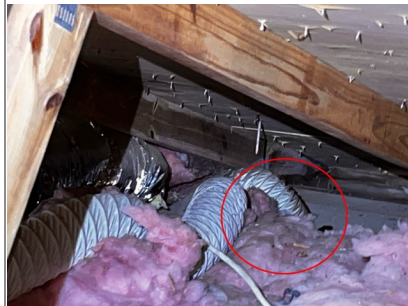
Exhaust ducting from top floor NW bathrooms fan terminates into the attic. These ducts should be routed to terminate at the exterior. Current installation has all the humidity and moisture from the bathroom, exhausting into the attic. To ensure no moisture problems occur, a licensed repair professional should reconfigure termination point of the exhaust duct to the exterior.

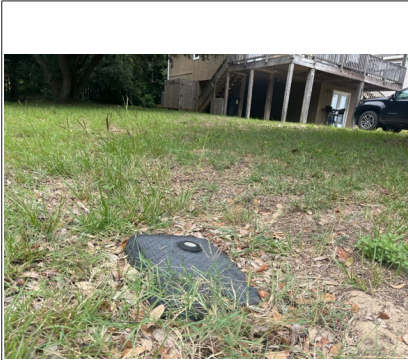
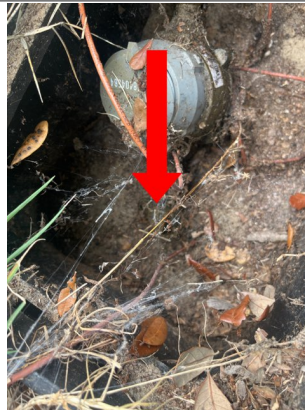
Main water shutoff is located within water meter enclosure at the SW corner of the property

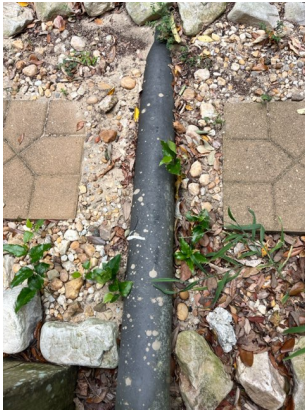
ABS plumbing used for drain, waste and vent plumbing at exterior is exposed to direct sunlight at ground floor NNW exterior. These plumbing materials are not designed for exposure to sunlight, leading to premature deterioration. A licensed plumber should evaluate and make any necessary corrective actions to ensure plumbing at these locations continue to operate as intended.

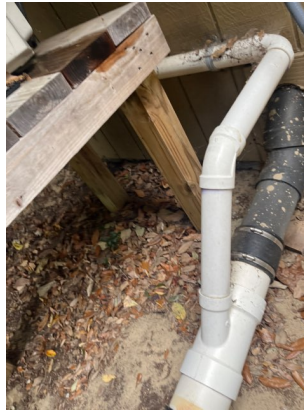
Sump discharge pipe is improperly installed. Current installation has the sump terminating into the drain, waste and vent pipes for the septic system. Generally accepted best plumbing practices recommend that the discharge point be separate from the dwv system. When connected, as is currently, the sump can overload the dwv/septic system and cause an overload. A licensed plumber should evaluate current design of sump system and make any necessary corrective actions

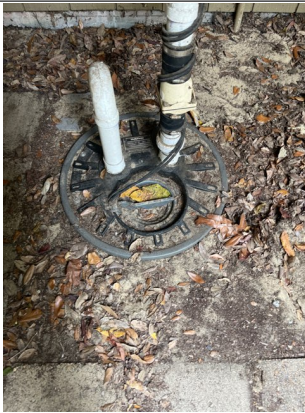
Sump not tested and it's functionality is excluded from the inspection.

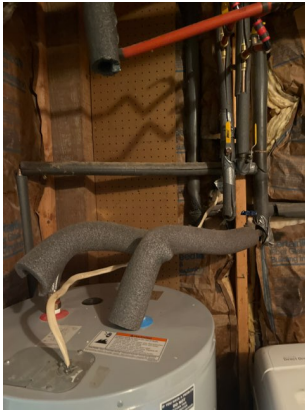
Expansion Tank not installed at the topside of unit. Generally accepted safe plumbing practices recommend a thermal expansion tank be installed between tank and cold water shutoff. A licensed plumber should evaluate for installation of a thermal expansion tank at this location,

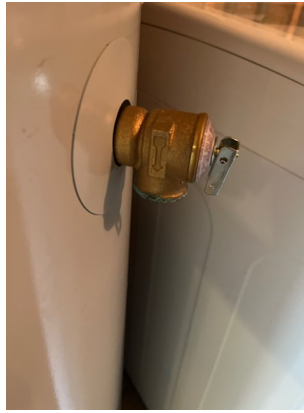
Temperature pressure relief valve is not installed at water heater. Safety hazard. Tprv is typically installed to relieve pressure in the tank if a malfunction occurs. This can save the tank from combustion in an emergency situation. Recommend a licensed plumber evaluate for installation of a temperature pressure relief valve.

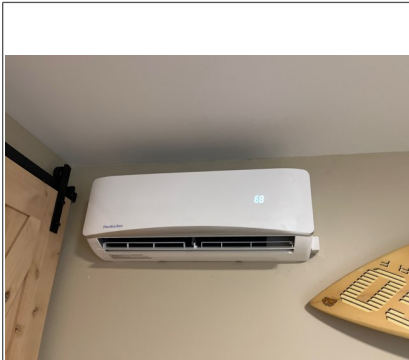
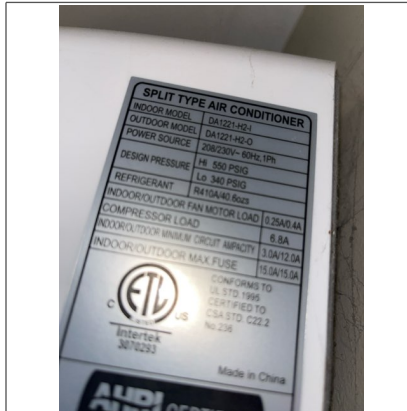
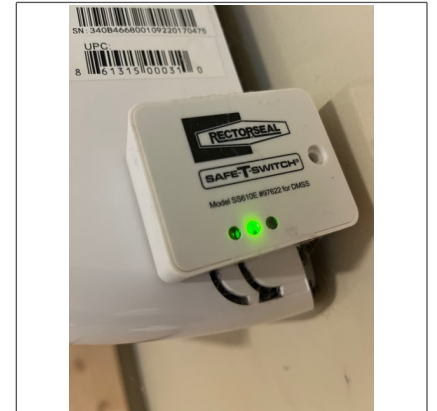
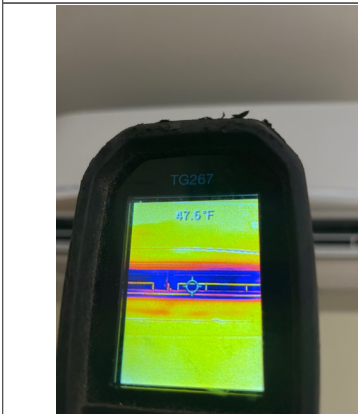
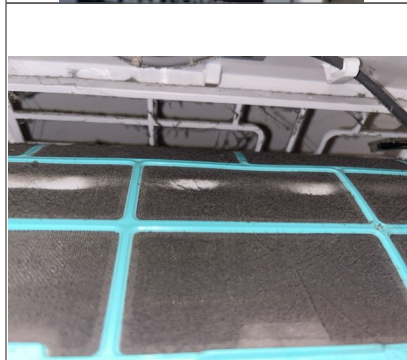
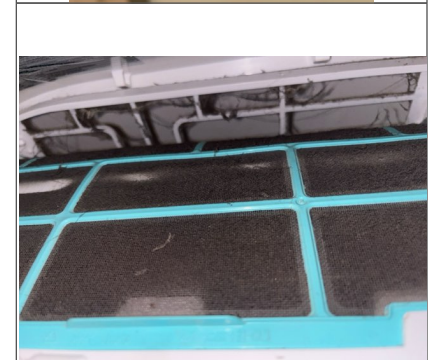
Filters at the unit was dirty and clogged. When proper airflow is not achieved, it can negatively affect functionality and effectiveness of the system during operation. Recommend cleaning filters throughout unit for enhanced usage.

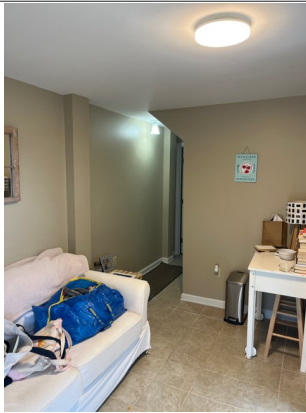
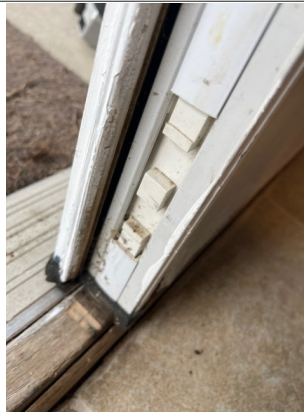
Lower Locking mechanism at the more W French door did not lock into place, and was unable to connect to the threshold to secure lower end of door. To restore originally intended functionality and stability, a licensed repair professional should evaluate door and make any necessary corrective actions
